## Case Histories (2)

By C. Overby,  
Consultant

# **Marich Pass – Lodvar**

Condition February 2006 after more than 24 years in service.

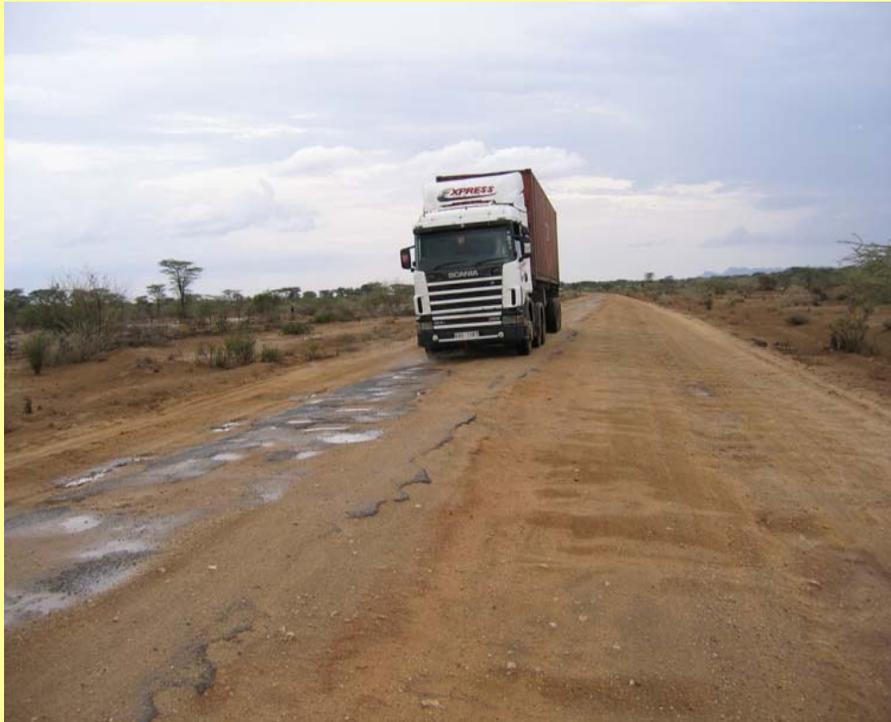
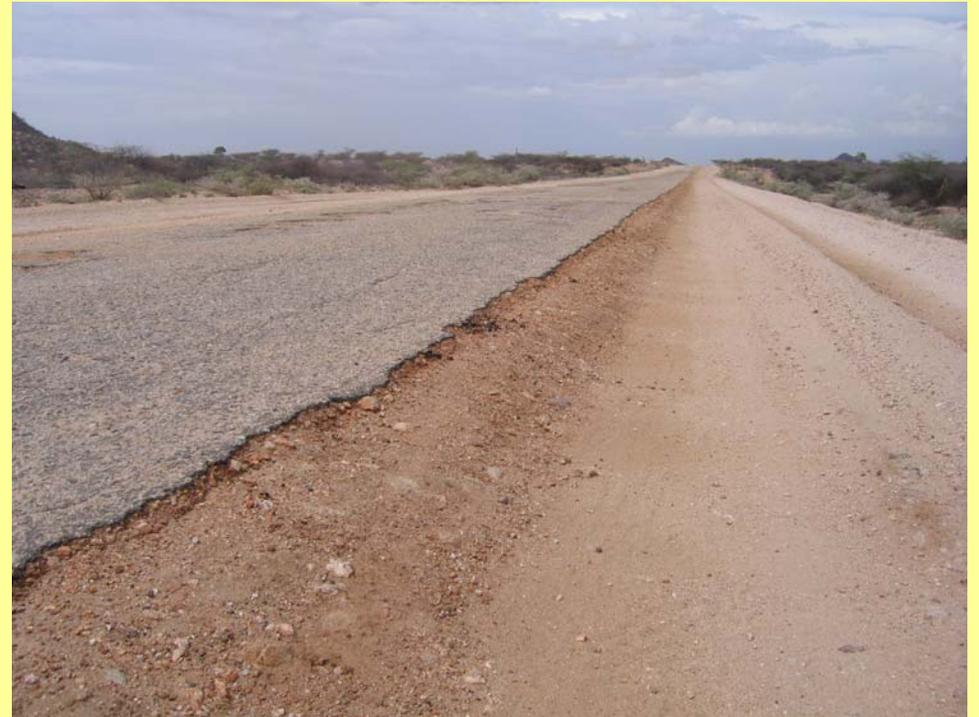
Sections of the badly deteriorated road surfacing and shoulders (left) and other sections of the same with much of the pavement structure still being intact and the graded shoulders providing an alternative roadway (right).

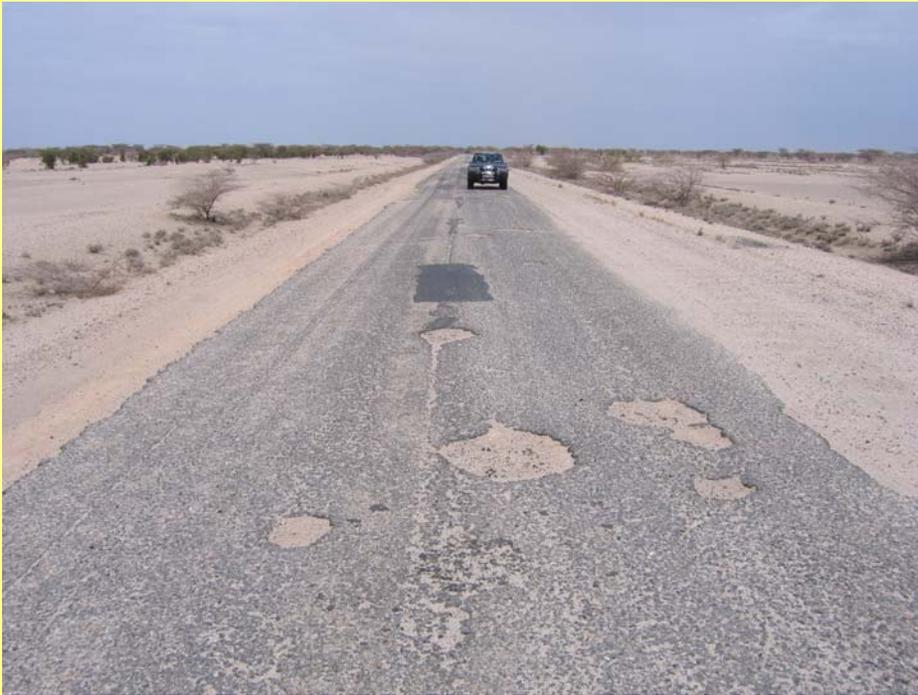
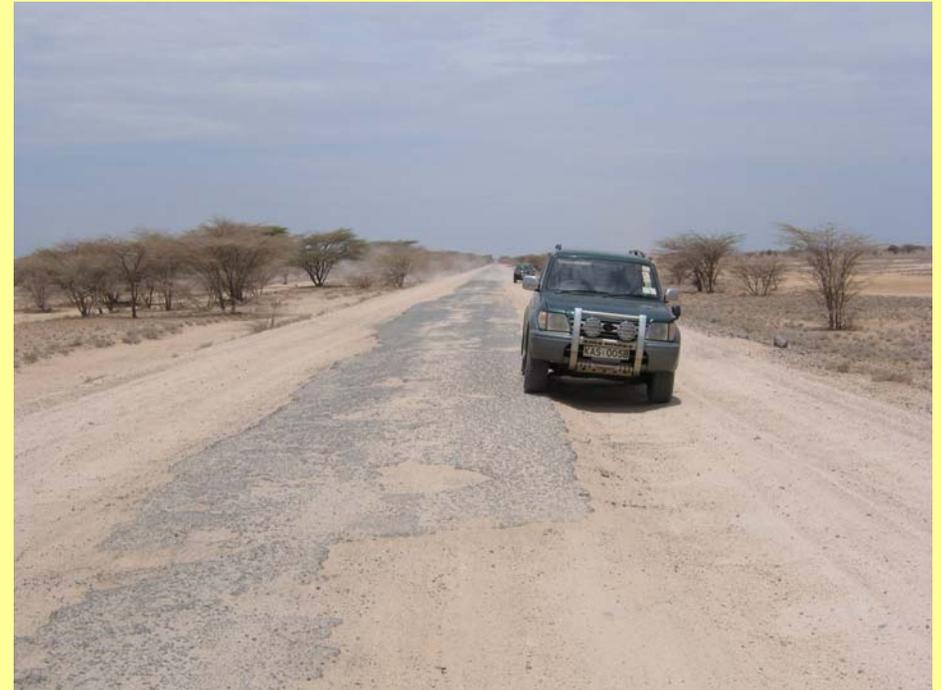
Condition February 2006 after more than 24 years in service.

Sections of the road with no maintenance (left) and with maintenance (right) illustrating the substantial benefits of carrying out simple, routine, maintenance to extend the service life of the road.

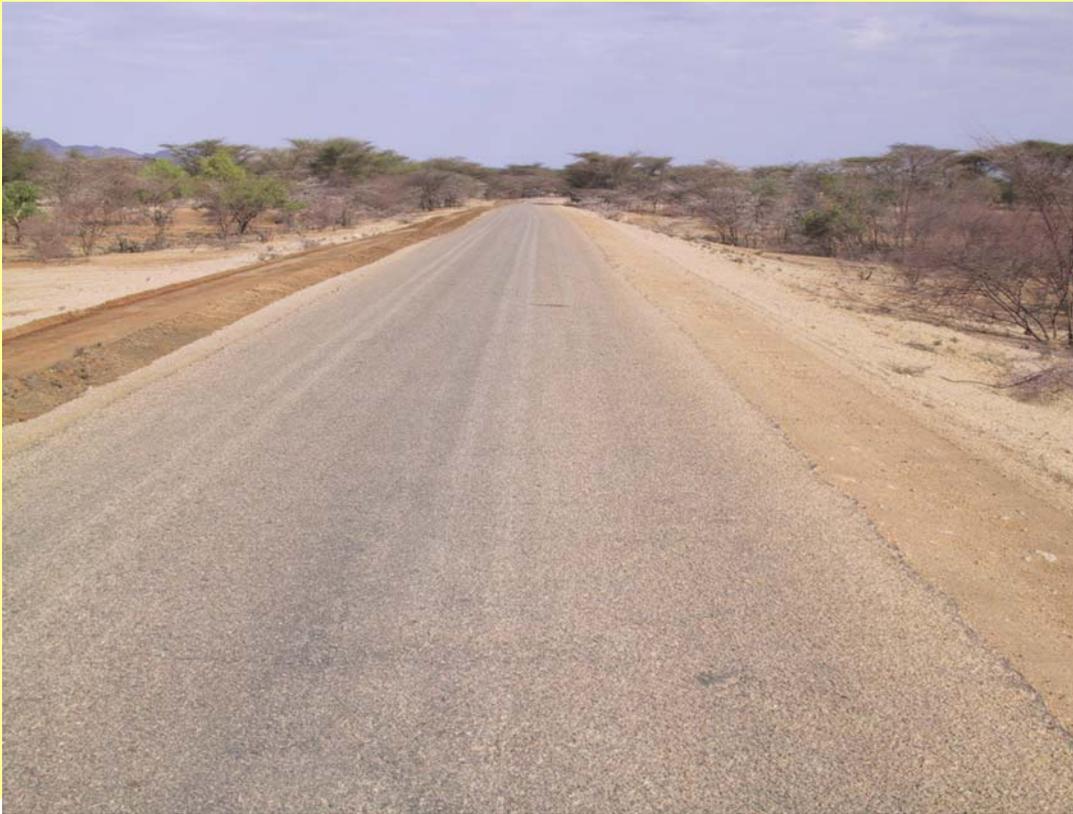
Condition February 2006 after more than 24 years in service.

The same road but being regularly maintained, although not with a reseal.

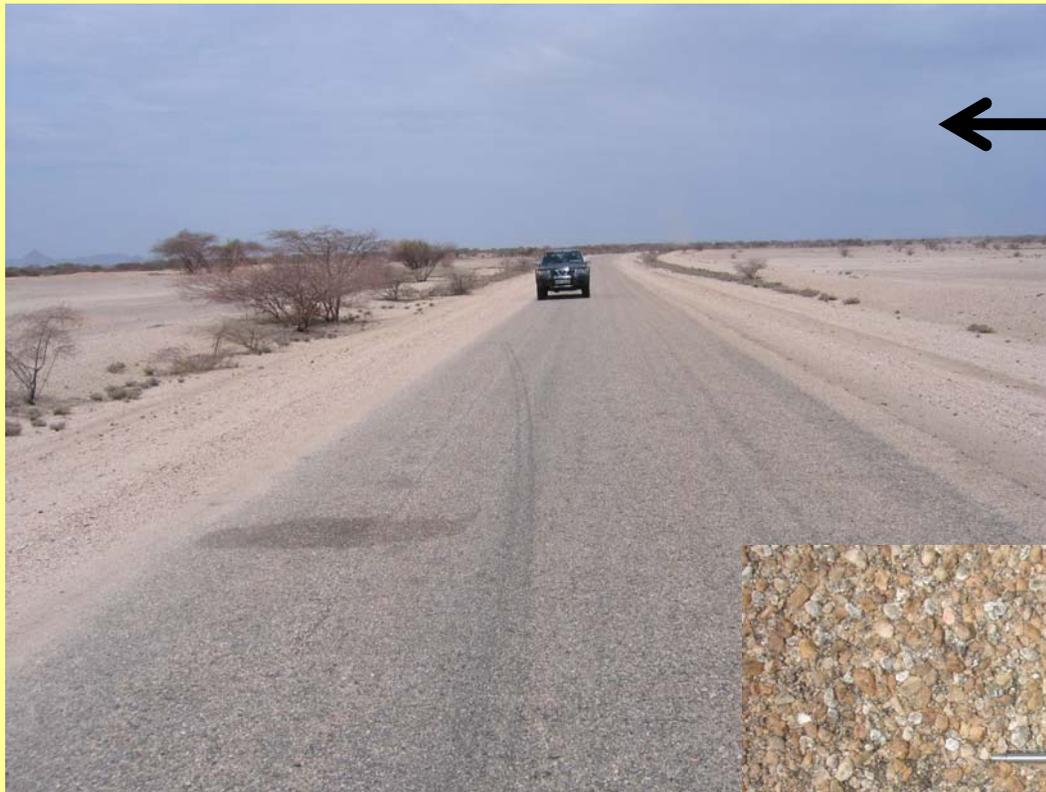
Condition February 2006 after more than 20 years in service.

← The Lodwar-Kalokol road looking towards Kalokol and showing the excellent condition of the pavement and surfacing after more than 20 years in service with practically no maintenance.

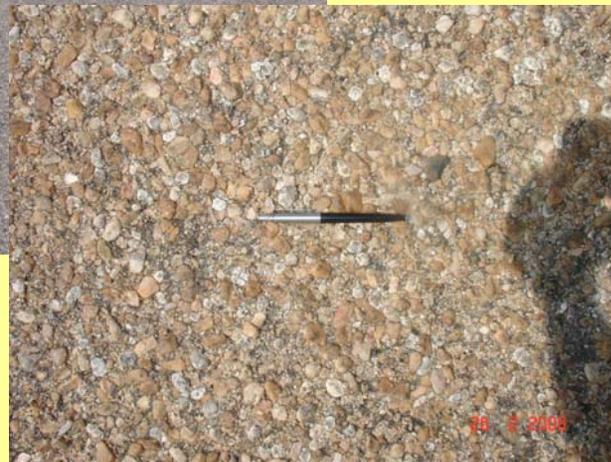
The double Otta seal surfacing constructed from screened quartzitic gravel obtained from adjacent to the road alignment

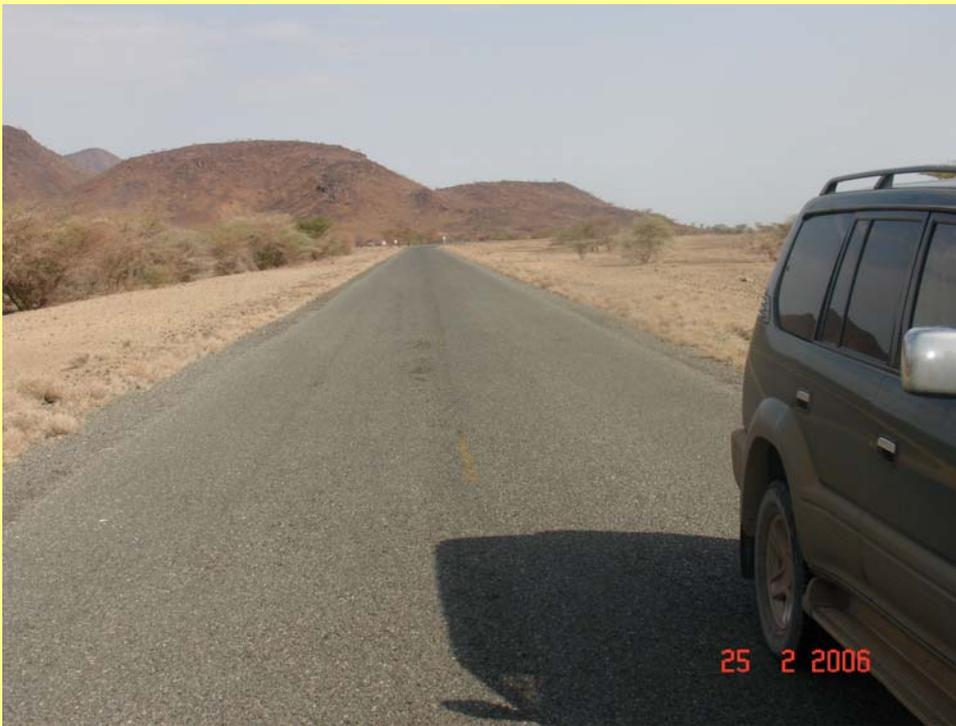
Condition February 2006

← The Lodvar-Lokichokio road looking towards Lokichokio and showing the generally good condition of the pavement albeit with some ravelling of the surfacing.

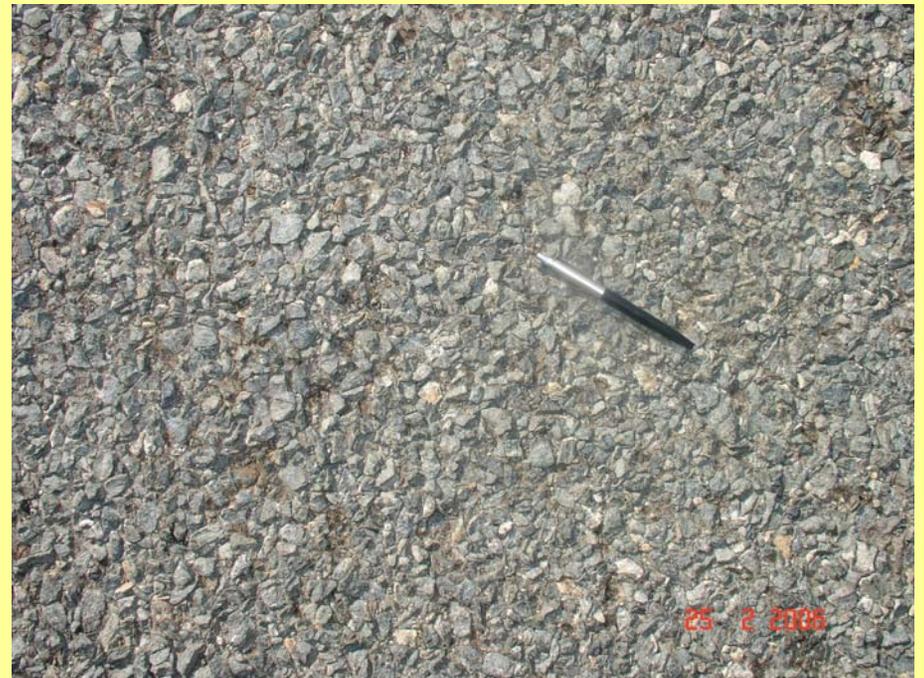
The double chip seal crushed basalt.

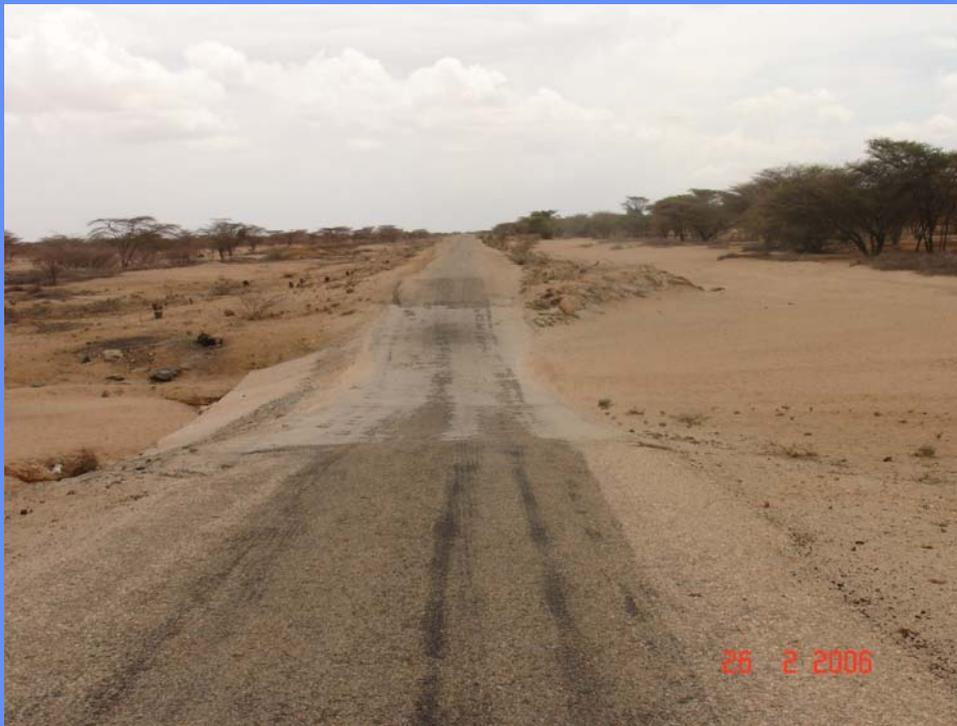
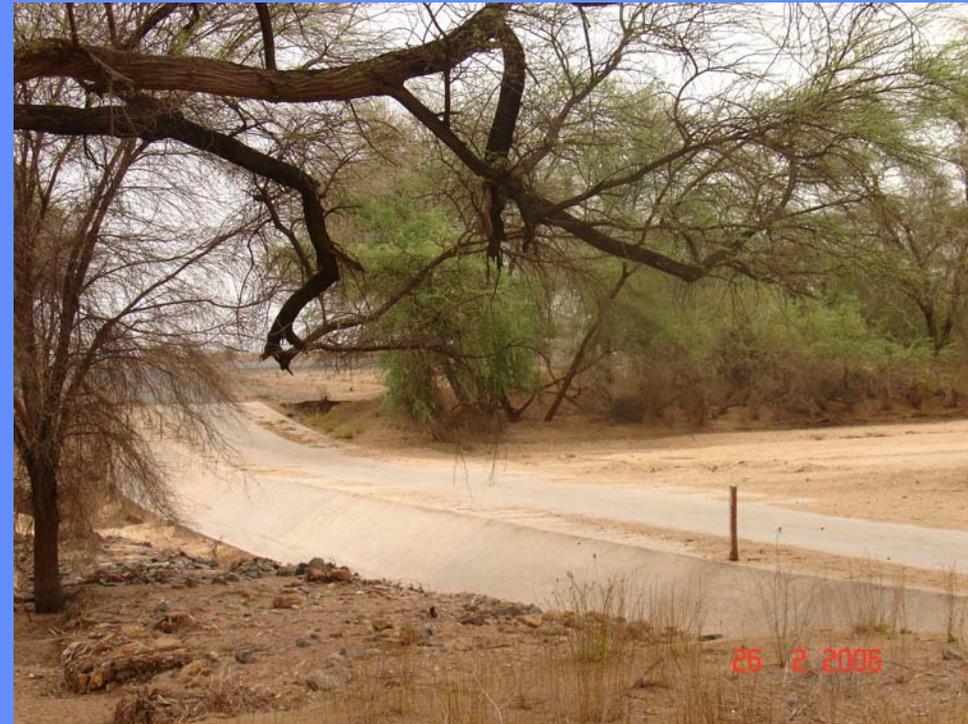
**Examples of well designed drifts along the Marich Pass-Lodwar road in which the bottom of the drift, forming the road surface is exactly at the level of the river bed – a requirement for good performance.**

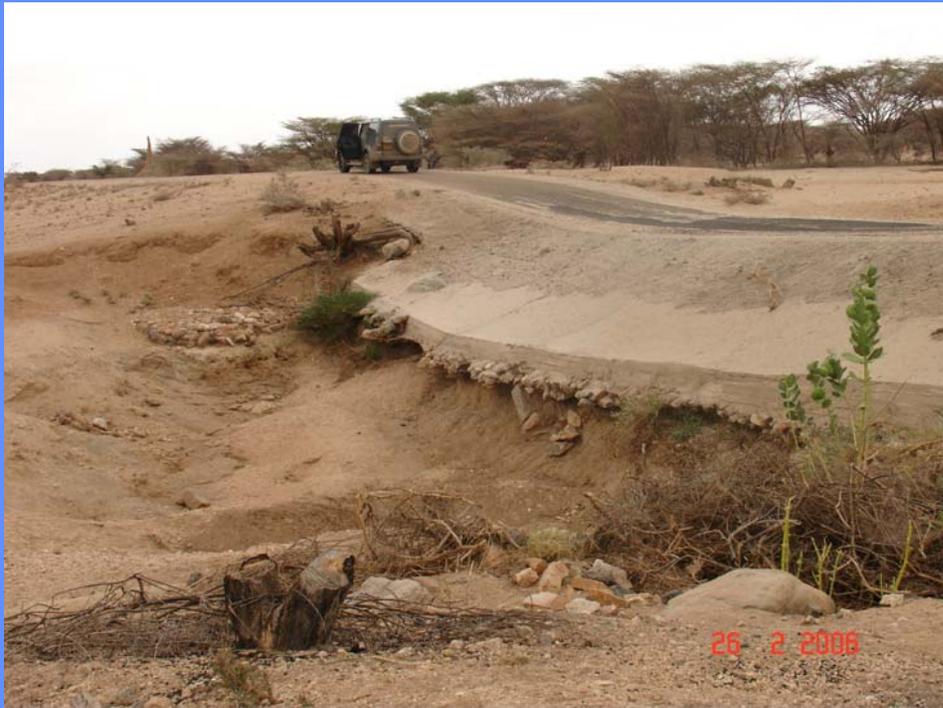
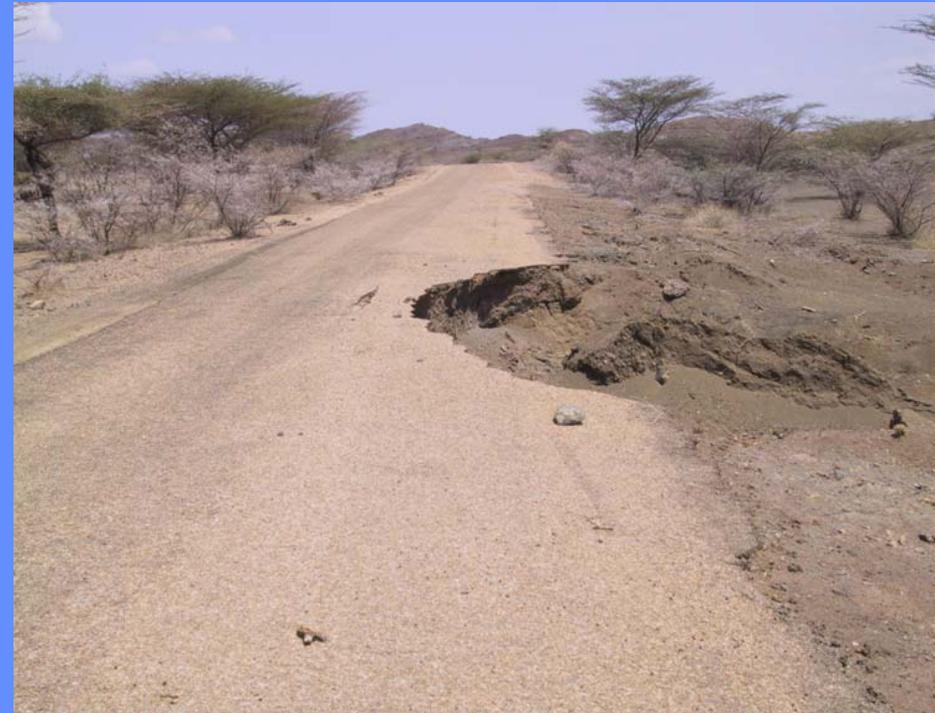
**After more than 22-24 years in service, most of the drifts and culverts have performed well. However, there were a number of instances of washouts and scour on the down-stream end of drifts and at culvert outlets.**

**Examples of poorly designed drainage structures along the Marich Pass – Lodwar road. Insufficient depth of the downstream skirt has resulted in extensive scour of the drift (left) and a washout at a culvert outlet along the Lodwar-Kalokol road.**

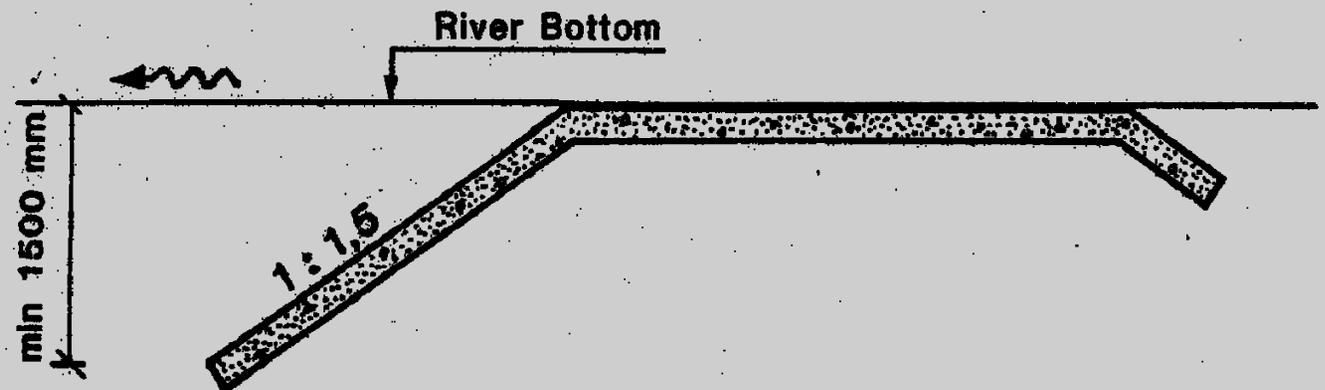
Those drifts that were constructed **NOT** in level with the stream/river bed either silted up or experienced serious erosion down stream, totally exposing the skirt and, in some cases, the underside of the drift.

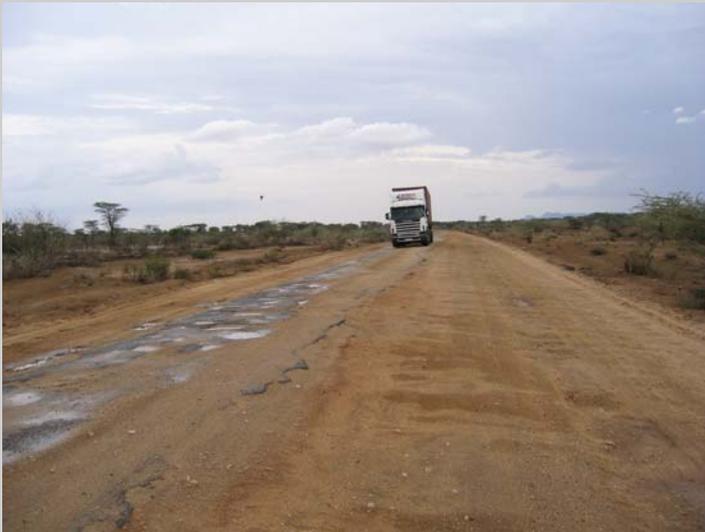
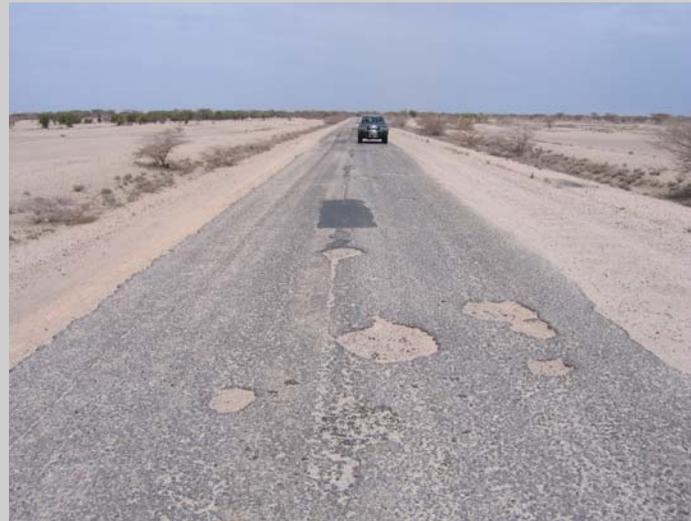
The serious lack of any maintenance activities for the last 10-15 years (apart from the Lokitaung-Lockichokio section and partly along the Lodwar-Kalokol section) has resulted in much of the remaining sections of part of the total length of the roads falling into a very critical condition.

Traffic loading of more than 2,0 million ESAs in contrast to the design traffic loading of 1,0 million ESAs
